## CHILEAN COPPER MINE – CASE STUDY

In late 2013 **newterra** was contracted to design, build and rapidly deploy a modular and pre-manufactured 10 liter per second metals precipitation and solids removal system for a copper mine in Chile.

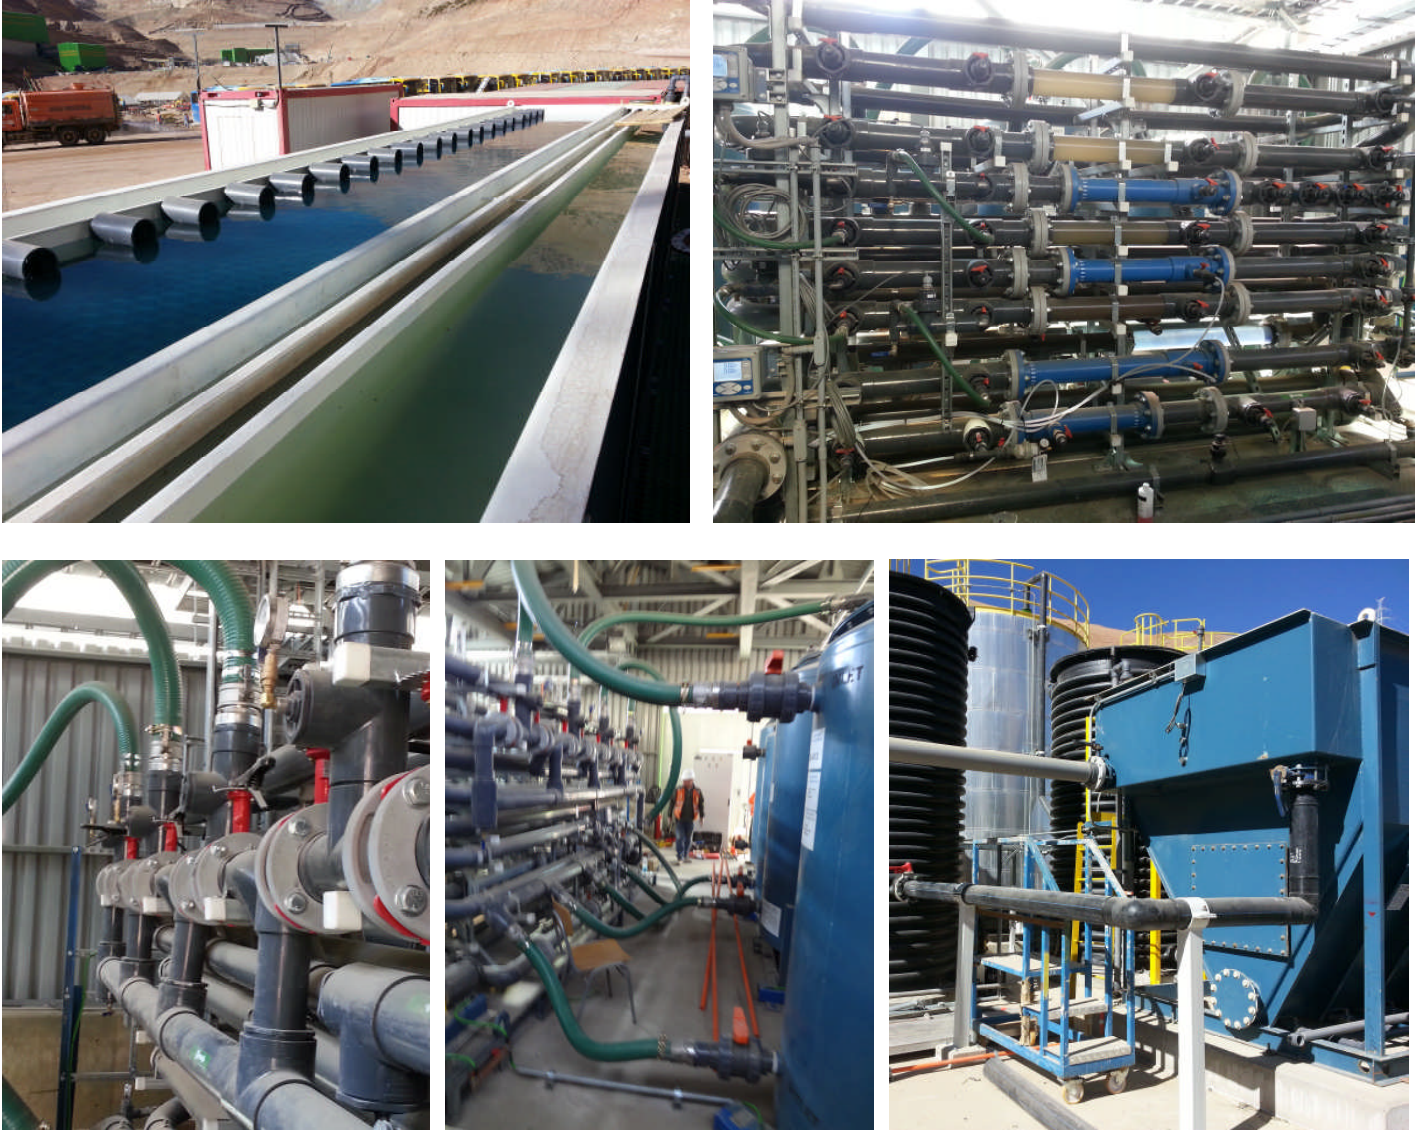
**Figure 2. Site Photos**

**newterra** met the schedule by designing a treatment solution utilizing pre-manufactured equipment packages that were already available in our North America based rental fleet. We rapidly modified and shipped the larger components by ocean freight which departed from our factory in early December. We following up with a second air freight shipment at the end of December which included the pre-wired and pre-tested control systems integrated onto the pump skids and pipe flocculator skid all modified to meet Chilean electrical requirements.

With the majority of the piping and electrical work completed and tested in our manufacturing plant, the installation, commissioning and startup went smoothly allowing the customer to have a system ready for operation to meet the regulatory requirements.

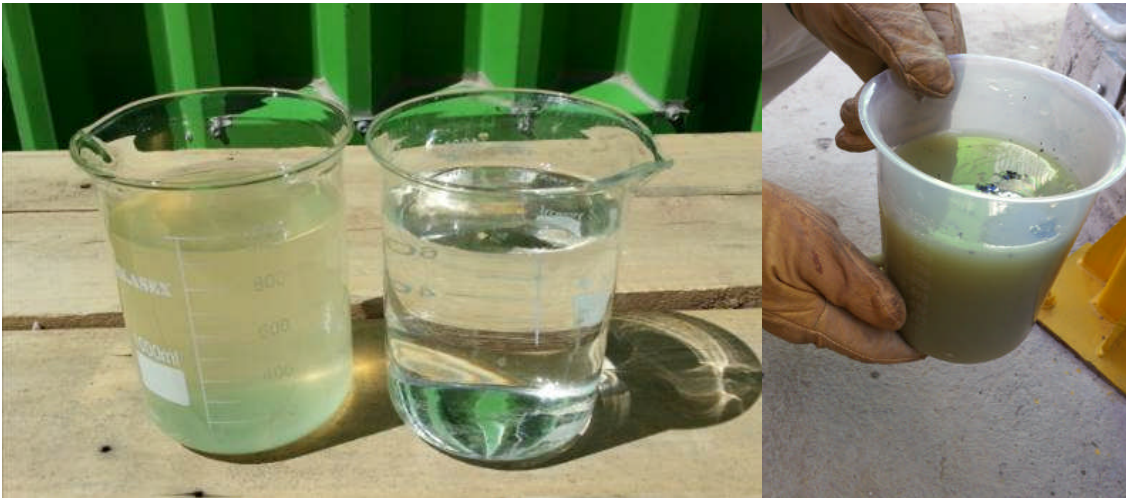
**Figure 3. Water Quality Photographs**

Inlet (left sample), Effluent (middle sample), Sludge in bottom of clarifier (right sample)
